Drone Facade Inspection Report

1 Sample Street, Melbourne VIC 3022 Sample Only (PS 12345S)

Part 2: Detailed Facade Report

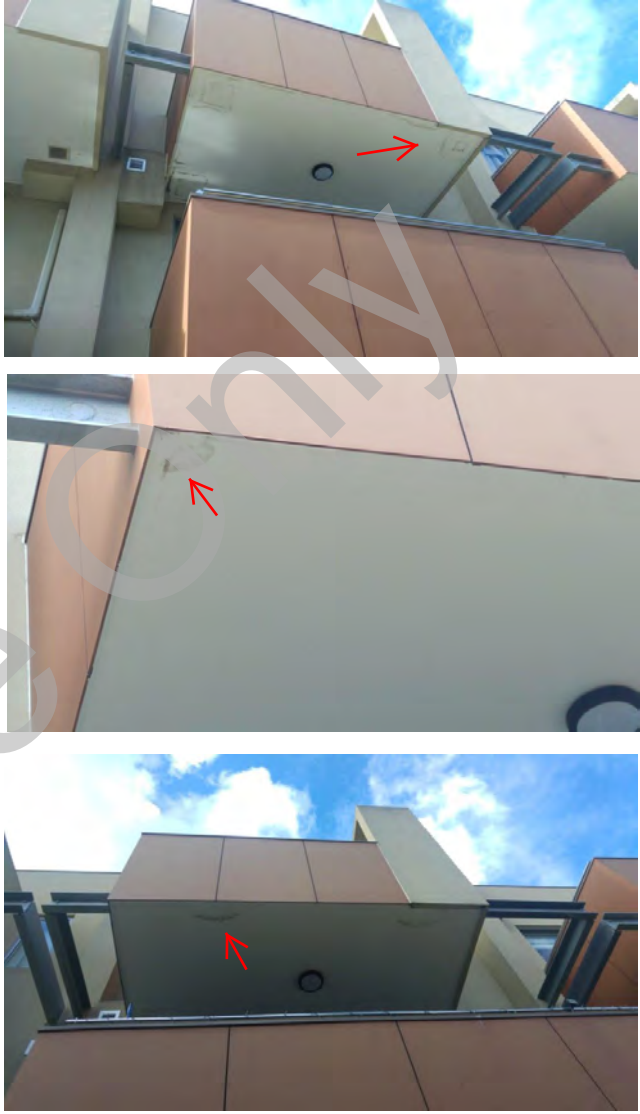
Item	Details	Photographic Details
1.	<p>Location: First Floor Balcony Soffits on the Western Facade.</p> <p>Finding: Throughout the western facade the first floor balcony soffits have water stains indicating that the water proof membrane throughout the first floor balconies have failed.</p> <p>Image 1 shows an exposed slab soffit in the north western corner of the balcony for Unit 10 where the paint has peeled off due to water ingress.</p> <p>Image 2 shows water staining on the bottom of the first floor slab soffit of Unit 9.</p> <p>Image 3 shows water staining on the north western corner of the first floor balcony of Unit 8.</p> <p>Recommendations: It is recommended that the water damaged balcony soffits are replaced with a new water proofing membrane.</p>

Item	Details	Photographic Details
2.	<p>Location: Sample Street Western Facade Second Floor Balcony Soffits.</p> <p>Finding: The second floor balcony soffits had water stains indicating that the water proofing membrane has failed throughout the second floor balconies.</p> <p>Image 1 is the second floor balcony soffit of Unit 9 where there is water staining in both the corners of the balcony soffits.</p> <p>Image 2 the second floor balcony soffit of Unit 8 has a water stain in the north western corner of the balcony soffit.</p> <p>Image 3 the second floor balcony soffit of Unit 7 has water staining across the western edge of the balcony soffit.</p> <p>Recommendations: It is recommended that the water damaged balcony soffits are replaced with a new water proofing membrane.</p>

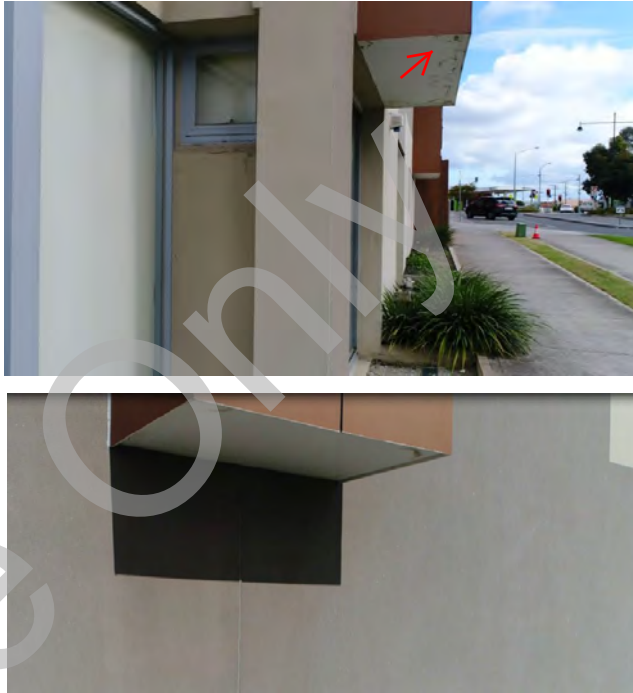
Item	Details	Photographic Details
3.	<p>Location: Northern Facade Soffits.</p> <p>Finding: Both the soffits on the northern facade have water stains indicating that water is seeping through the soffit. Based off this observation the soffit's water proofing membrane has failed allowing water ingress.</p> <p>Recommendations: It is recommended that the water proofing membrane on the soffits are replaced.</p>

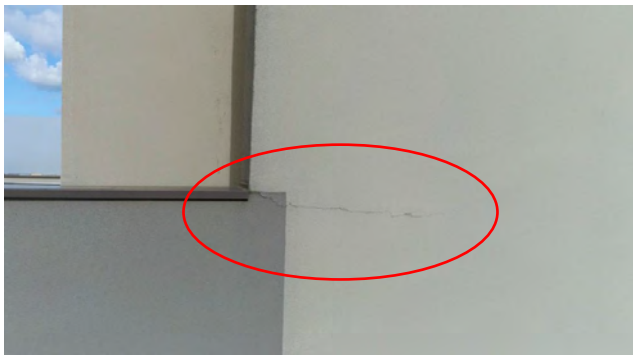
4.	<p>Location: Unit 10 Second Storey Balcony.</p> <p>Finding: There is a hairline crack at the edge of the parapet of the second storey balcony.</p> <p>Recommendations: It is recommended that the hairline crack is monitored to ensure that it does not worsen.</p>

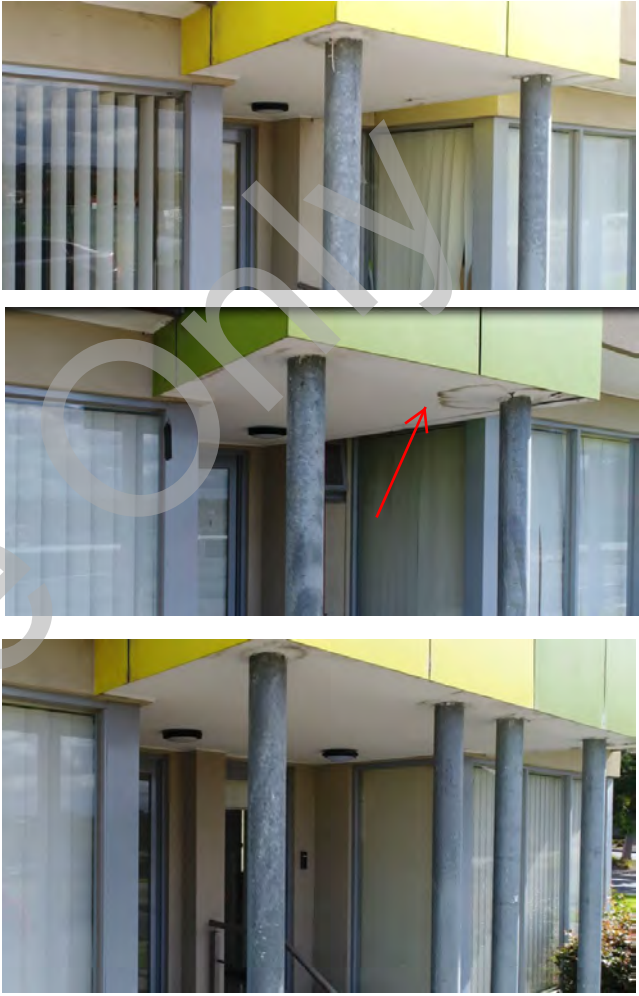
Item	Details	Photographic Details
7.	<p>Location: Ground Floor Balcony Soffits.</p> <p>Finding: The first floor balcony soffits have significant water damage around the steel columns. Based off these observations the soffits have not been adequately water proofed.</p> <p>Recommendations: It is recommended that the balcony soffits on the first floor are replaced.</p>

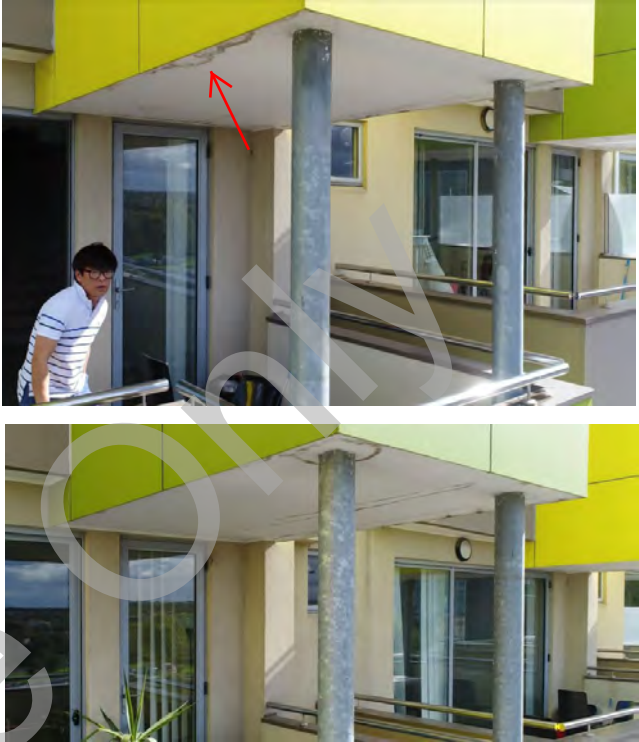
Item	Details	Photographic Details
8.	<p>Location: The Second Storey Balcony Soffits.</p> <p>Finding: The second storey balcony soffits have water staining indicating that the balconies water proofing membrane has failed allowing water to ingress onto the soffit below.</p> <p>Recommendations: It is recommended that the second storey balconies throughout the eastern facade are replaced.</p>

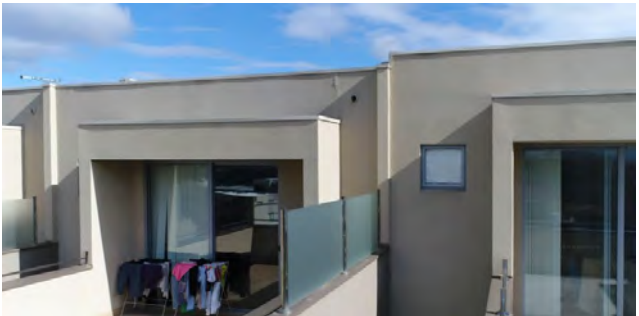
9.	<p>Location: Second Storey Facade.</p> <p>Finding: The facade below the capping on the eastern facade has a large crack in the render. Based off this observation water is seeping underneath the capping on the top of the facade causing cracking to the render on the facade below.</p> <p>Recommendations: It is recommended that the capping above the damaged section is replaced and then the render is repaired and repainted so that it matches in with finish of the external facade.</p>

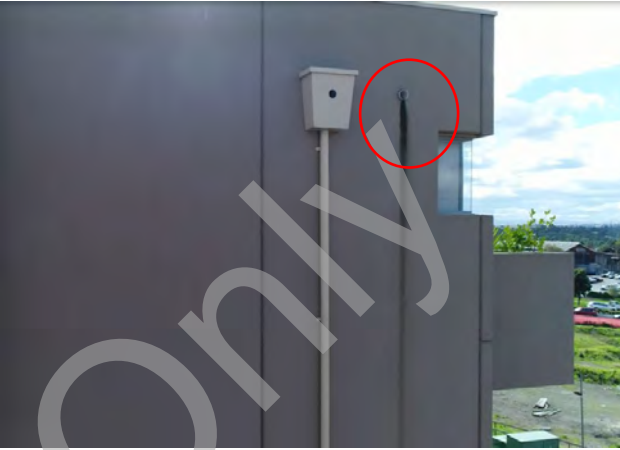
Item	Details	Photographic Details
10.	<p>Location: South Eastern Corner Second Storey Overflow Pipe.</p> <p>Finding: The overflow pipe on the second storey south eastern corner has not been connected a downpipe and is leaking water onto the facade.</p> <p>Recommendations: It is recommended that the overflow is connected a rain head, which is then connected to a downpipe.</p>

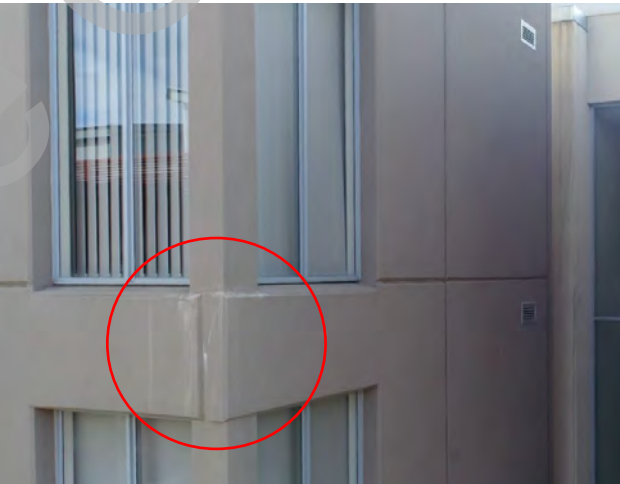
11.	<p>Location: Second Storey Window Frame.</p> <p>Finding: The window frame on the second storey has signs of efflorescence at the bottom of the column adjacent to the window sill. Based off these observations water from the window sill is seeping into the bottom of the column.</p> <p>Recommendations: It is recommended that the window frames are reinstalled with a damp proof course on the window sill to prevent water ingressing into the window sill.</p>

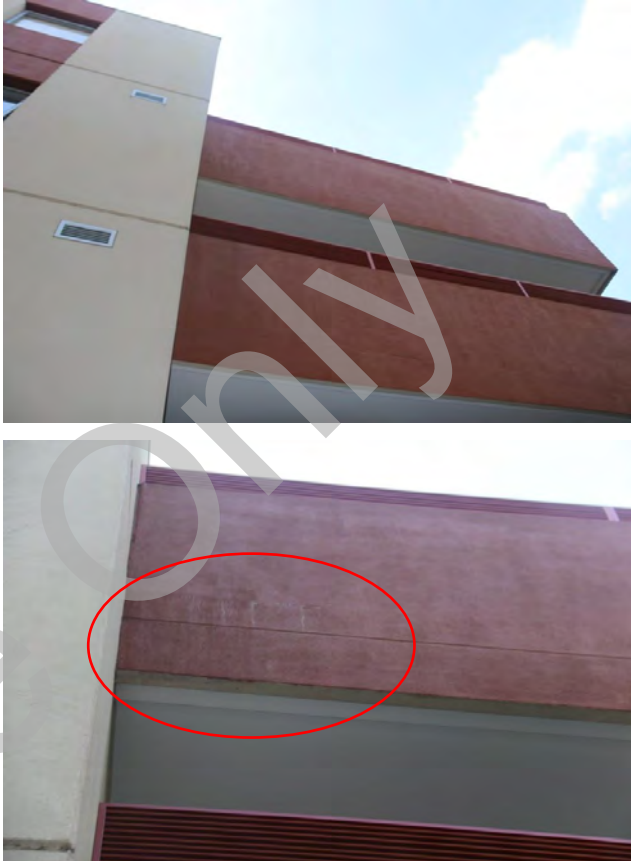
Item	Details	Photographic Details
12.	<p>Location:</p> <p>Third Storey Balcony Parapet on Western Side.</p> <p>Finding:</p> <p>The third storey balcony parapet has a hairline crack with efflorescence seeping out of it. Given the balcony parapet has not been capped with flashing water has seeped into the balcony parapet causing a hairline crack in the render of the parapet below.</p> <p>Recommendations:</p> <p>It is recommended that the balcony parapet is capped with an appropriate flashing to prevent water ingress into the render of the parapet.</p>

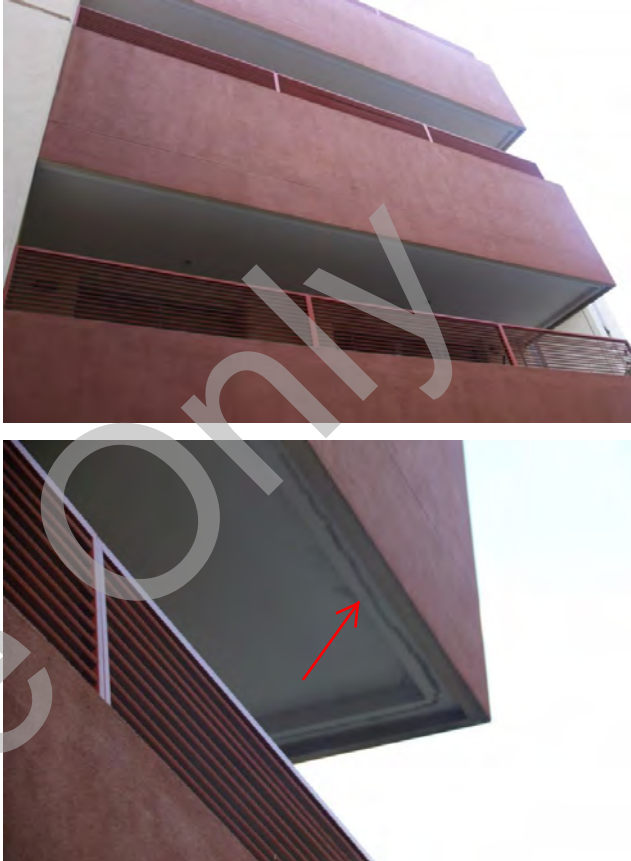
Item	Details	Photographic Details
13.	<p>Location: Second Storey Balcony on the West Side of the South Facade.</p> <p>Finding: The edge of the second storey balcony soffit has water stains indicating that the water proofing membrane has failed allowing water to seep into the balcony soffit.</p> <p>Recommendations: It is recommended that the balcony soffit water proofing membrane is replaced and the damaged sections of the soffit is repaired and repainted.</p>

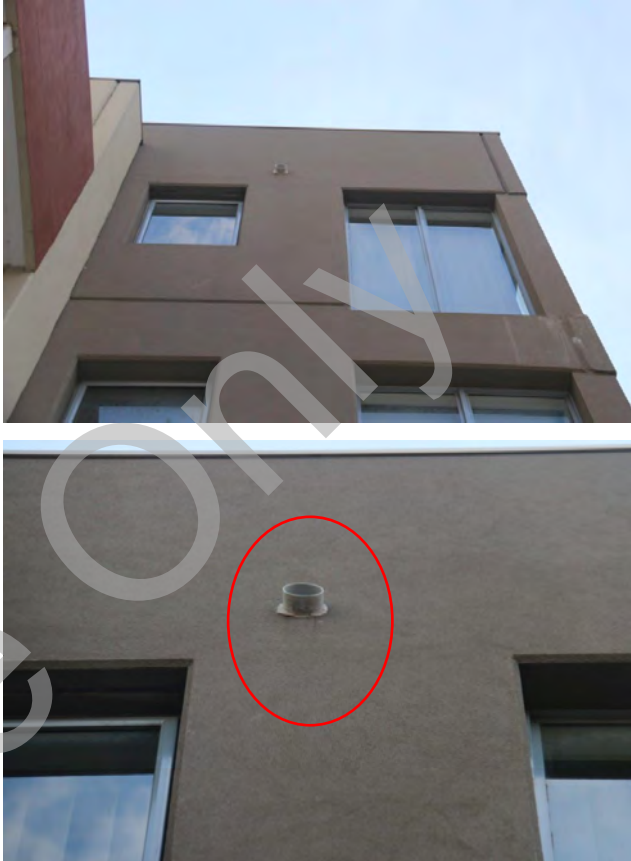
Item	Details	Photographic Details
16.	<p>Location:</p> <p>Third Storey Overflow.</p> <p>Finding:</p> <p>The overflow to the roof is not connected to a downpipe meaning that water will track down the facade accelerating the damage to the external facade.</p> <p>Recommendations:</p> <p>It is recommended that the overflow is connected to a rainhead and downpipe, so that the discharged water does not track along the facade of the building.</p>

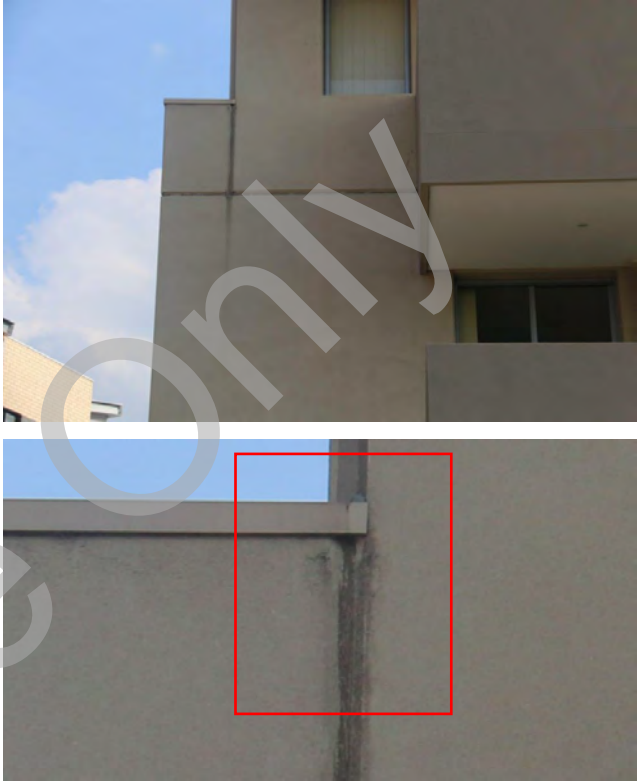
Item	Details	Photographic Details
17.	<p>Location: Second Floor Balcony Parapet on the South Eastern Corner.</p> <p>Finding: The capping on the balcony parapet has been installed over the vertical articulation joint on the balcony parapet. Water is seeping around the edge of the capping and is tracking down the channel of the articulation joint, this is shown by the dirt stains in Image 2.</p> <p>Recommendations: It is recommended the capping on the parapet of the balcony is replaced with a capping that has a drip edge further away from the building to prevent water from tracking down the articulation joint.</p>

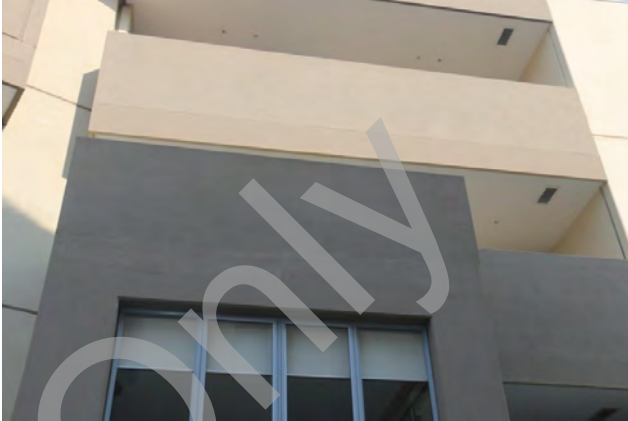
Item	Details	Photographic Details
20.	<p>Location: First Storey Balcony Parapet.</p> <p>Finding: There is a hairline crack on the first storey balcony with efflorescence stains. The parapet has not been capped with flashing, this allows water to send into the top edge of the balcony parapet. The water seeps into the render of the parapet causing cracking at the bottom of the balcony parapet.</p> <p>Recommendations: It is recommended that flashing is installed on the parapet of the balcony.</p>

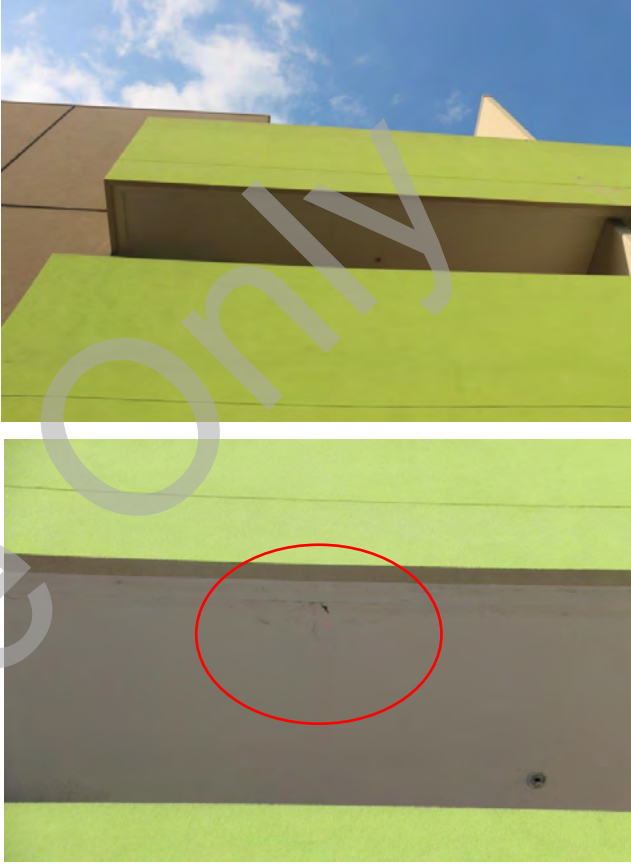
Item	Details	Photographic Details
21.	<p>Location: Third Storey Balcony Soffit on the North Western Corner.</p> <p>Finding: The western edge of the balcony soffit has water damage indicating that the water proofing membrane has failed.</p> <p>Recommendations: It is recommended that the water proofing membrane is replaced and the damaged section of the soffit is repaired and repainted.</p>

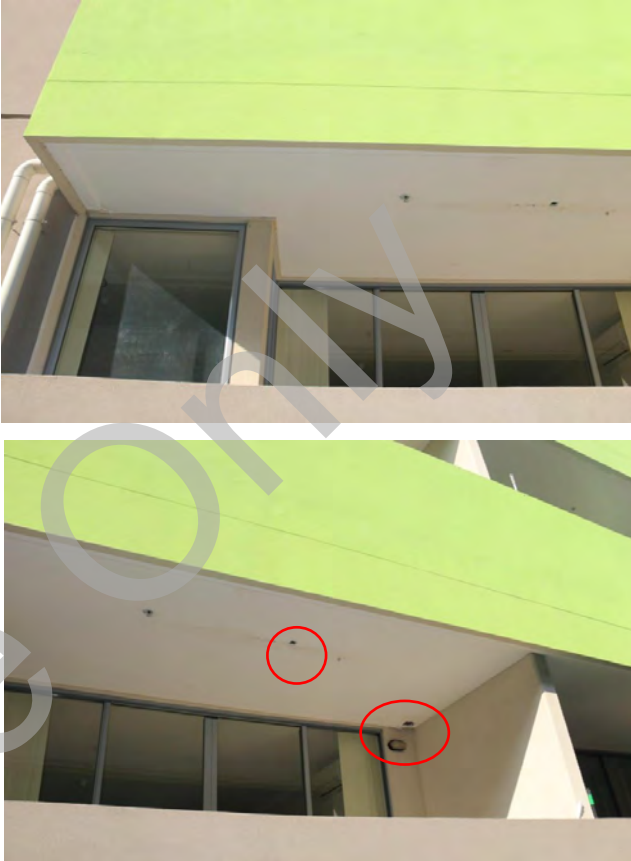
Item	Details	Photographic Details
22.	<p>Location:</p> <p>Second Storey Balcony Soffit.</p> <p>Finding:</p> <p>The balcony soffit has water damage to the soffit. Inspection holes have been cut into the soffit.</p> <p>Recommendations:</p> <p>It is recommended that the water proofing membrane is replaced and the balcony soffit is replaced.</p>

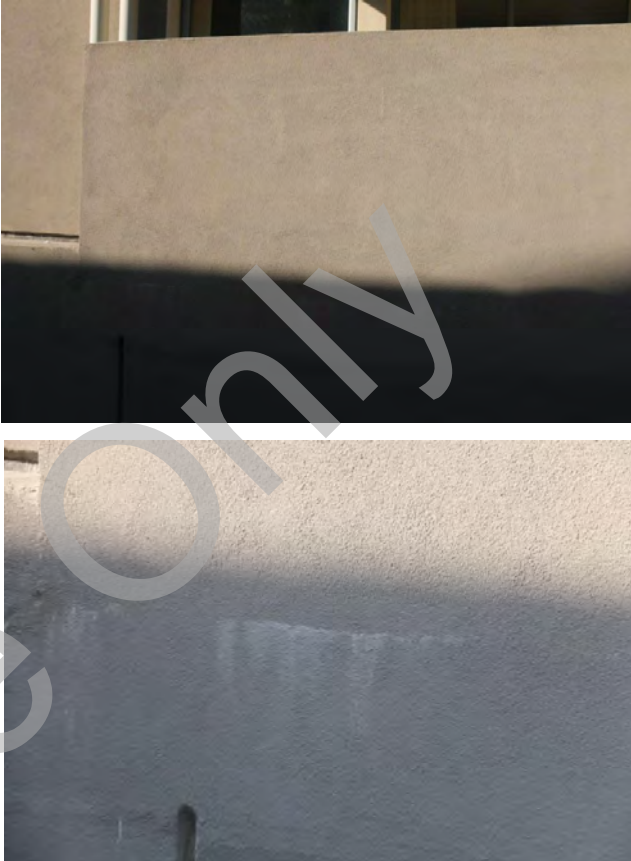
Item	Details	Photographic Details
23.	<p>Location:</p> <p>First Floor Balcony Parapet North Western Corner of the Western Facade.</p> <p>Finding:</p> <p>The balcony parapet has efflorescence stains from water seeping through the render of the parapet, due to the top edge not being capped with the appropriate flashing.</p> <p>Recommendations:</p> <p>It is recommended that the parapet is capped with flashing to prevent future water ingress and the damaged section of the rendered parapet is replaced.</p>

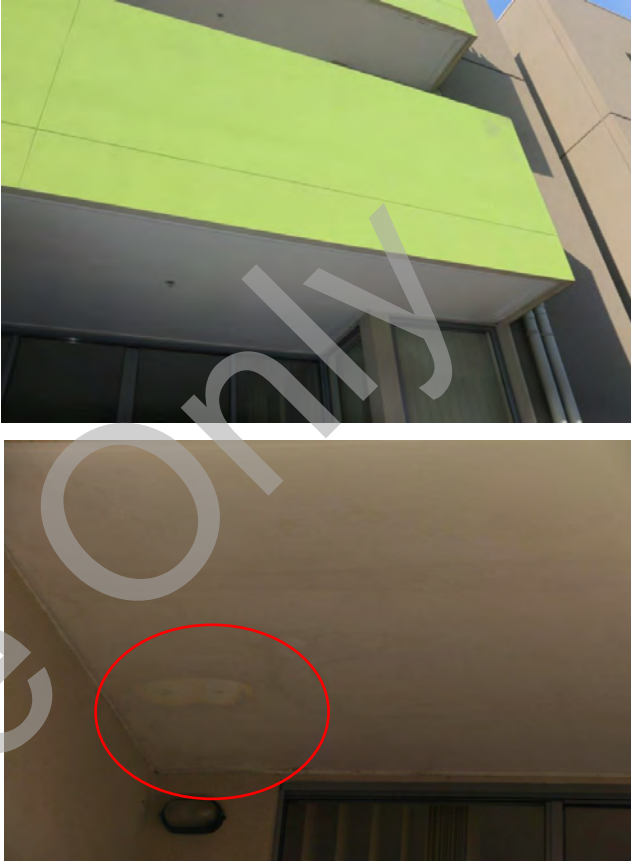
Item	Details	Photographic Details
25.	<p>Location: Second Storey Balcony Soffit on the Western Facade.</p> <p>Finding: The balcony soffit has been repaired with the paint on the patch not matching the finish of the balcony soffit.</p>

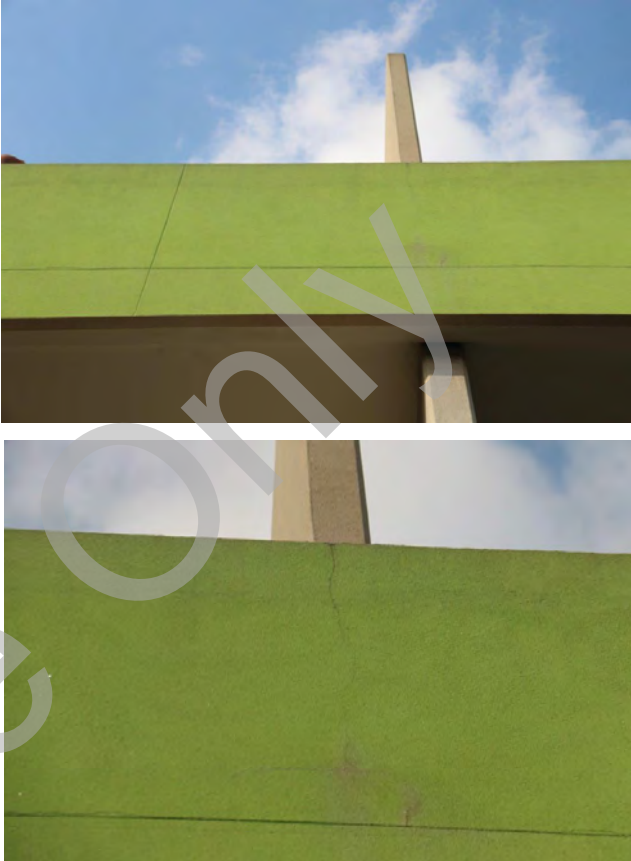
Item	Details	Photographic Details
26.	<p>Location:</p> <p>Third Storey Balcony Parapet.</p> <p>Finding:</p> <p>The parapet to the third storey balcony has hairline cracks due to water tracking down the parapet of the balcony. Articulation joints have also been rendered over.</p> <p>Recommendations:</p> <p>It is recommended that the parapet is capped with an appropriate flashing to prevent future water ingress.</p>

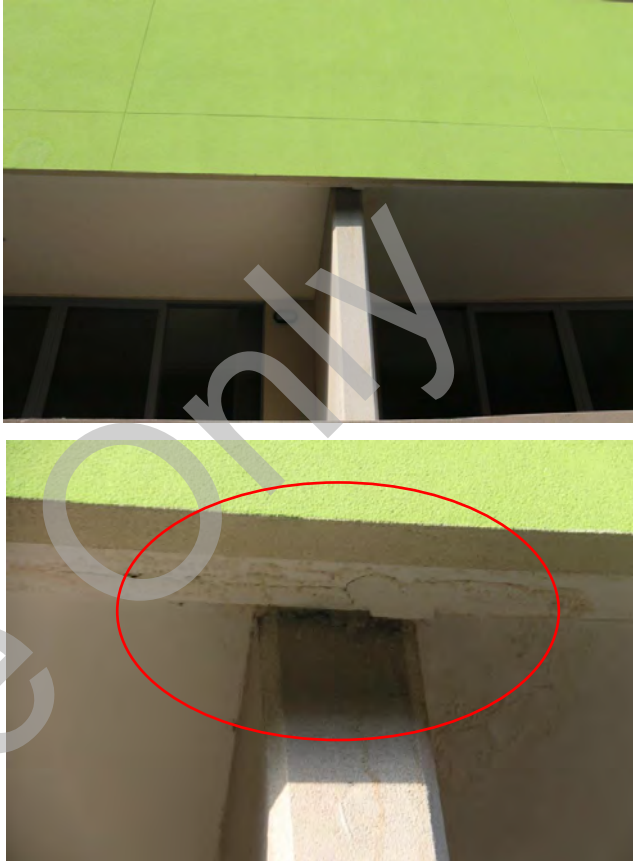
Item	Details	Photographic Details
27.	<p>Location: Second Storey Balcony Soffit on the South Western Corner.</p> <p>Finding: The edge of the balcony soffit has water damage due to water seeping through the balcony due to a failed water proofing membrane.</p> <p>Recommendations: It is recommended that the water proofing membrane of the balcony is replaced and the damaged sections of the balcony soffit is repaired.</p>

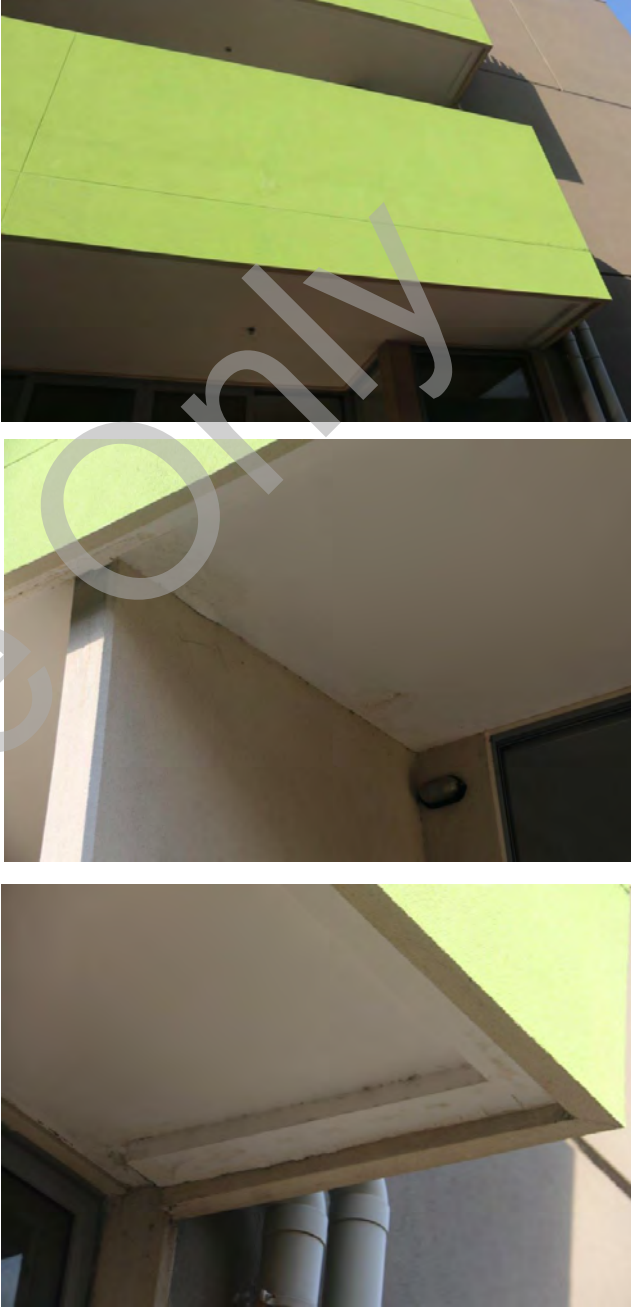
Item	Details	Photographic Details
28.	<p>Location: Second Storey Balcony Soffit towards the South of the Western Facade.</p> <p>Finding: The balcony soffit has been water damaged indicating that the water proofing membrane has failed.</p> <p>Recommendations: It is recommended that the damaged sections of the balcony soffit are replaced and the failed water proofing membrane is replaced.</p>
